RARITAN RIVER BASIN
RAHWAY RIVER, UNION COUNTY
NEW JERSEY

BLOODGOODS POND DAM

NJ 00370

PHASE 1 INSPECTION REPORT NATIONAL DAM SAFETY PROGRAM

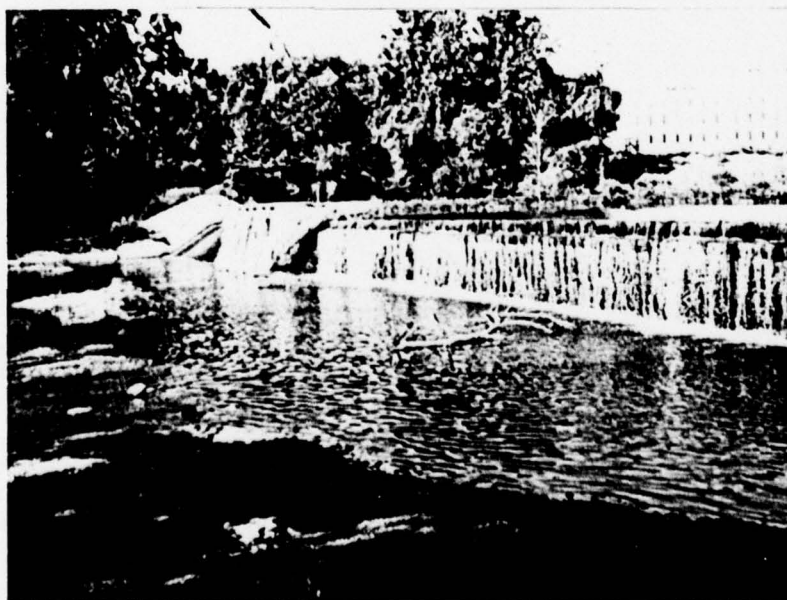
Downstream view of dam

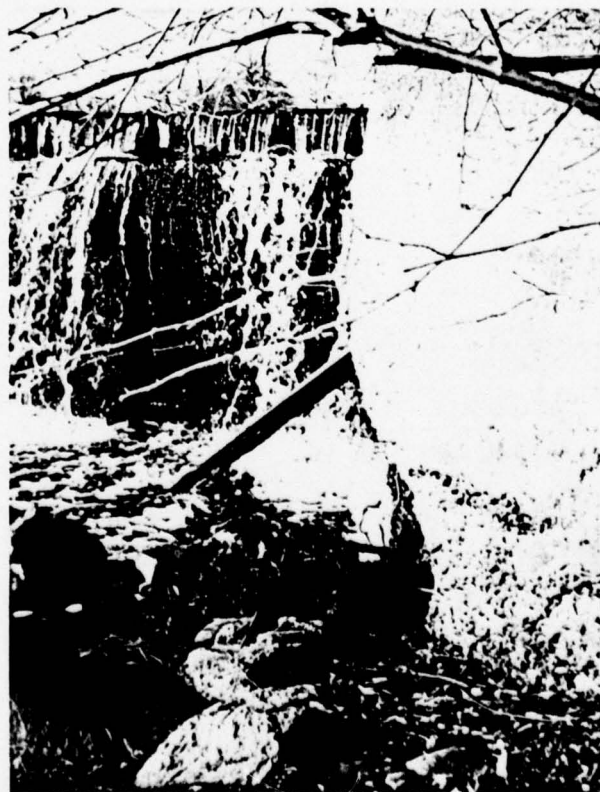
The original 158 foot section of concrete spillway and the left abutting wingwall also exhibited signs of advanced deterioration and cracking. The wingwall concrete is extensively eroded at the base and the reinforcement is exposed and corroded (see photos). The downstream edges of the top apron slab and the buttress wall are cracked and spalled. A close inspection of this area was prevented by the continuous discharge over the spillway.

View of east wingwall

All disintegrated concrete at the left wingwall, flood-gate structure, and along the slab and buttress spillway should be repaired and/or replaced where deemed necessary. Further, a rapid and safe method of gaining access to the flood-gate structure should be provided, preferably by means of a catwalk. The inoperable 30" Ø sluice gate should be repaired or replaced.
